# **Trip Report**

## **2003 Annual Inspection of the Grand Junction, Colorado, Office Facility**

### **Defense Decontamination and Decommissioning Program Site**

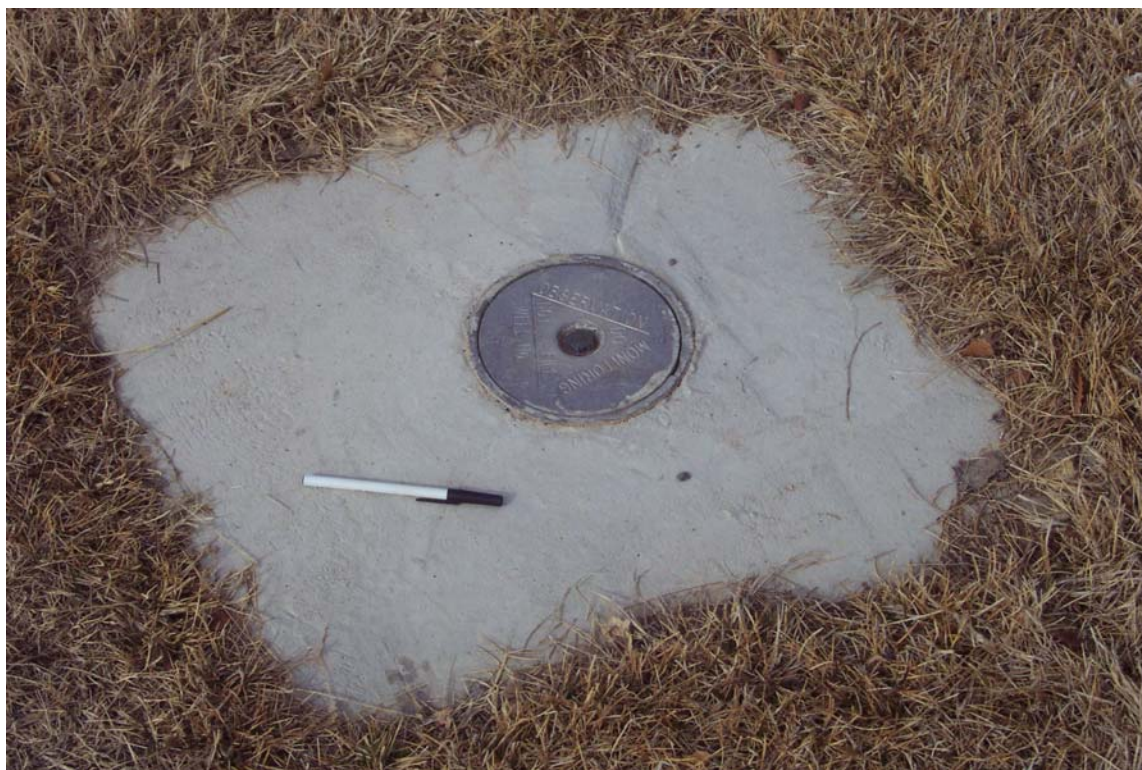
Three of the flush-mounted wells (11–1S, 14–13NA, and GJ01–01) do not have visible identification numbers (PL–1 and PL–2). One flush-mounted well (GJ01–02) has its identification marked in red paint on the concrete collar, and two flush-mounted wells (10–19N and GJ84–4) have their identification numbers marked on metal signs next to the wells. It is recommended that all the flush-mounted wells have permanent visible identification numbers indicated on the caps or covers.

1. None of the flush-mounted monitor wells have their identification numbers permanently marked on their caps or covers.

GJO 02/2003. PL-1. Cap of monitor well GJ01-01.

**Recommendation:** Die-stamp or engrave identification numbers on all flush-mounted monitor wells.

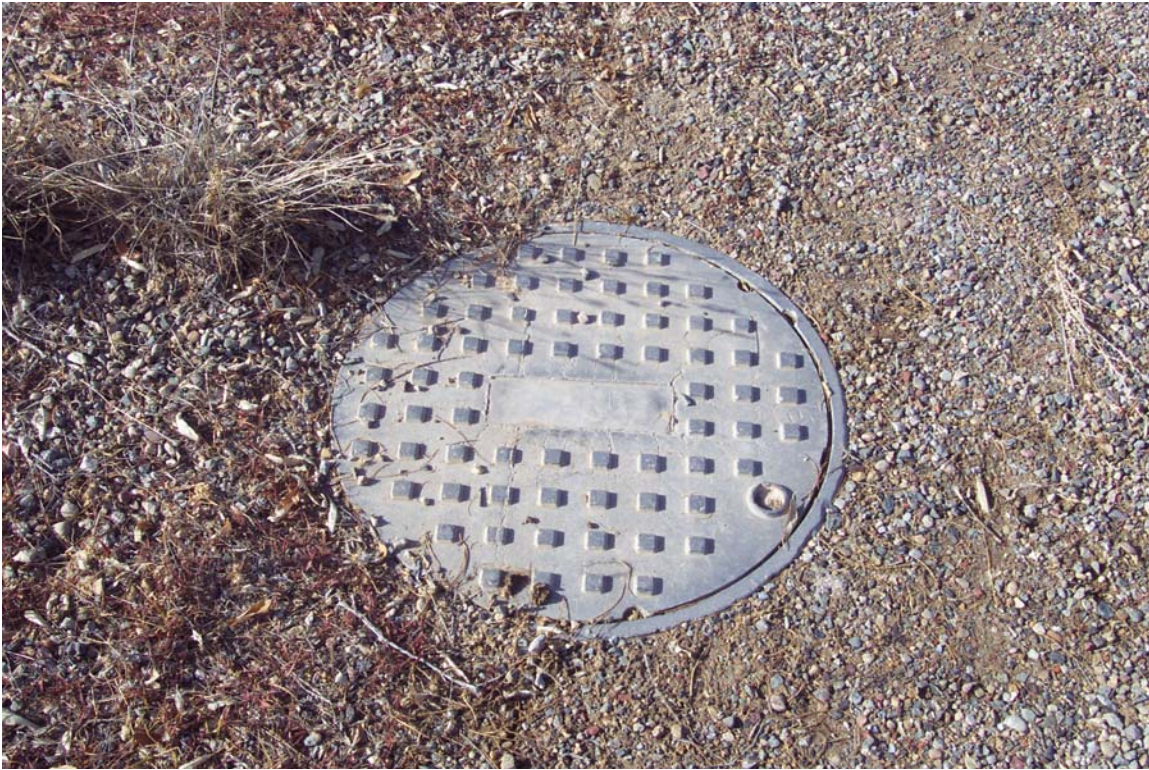
GJO 02/2003. PL-2. Manhole cover on monitor well 11-1S.

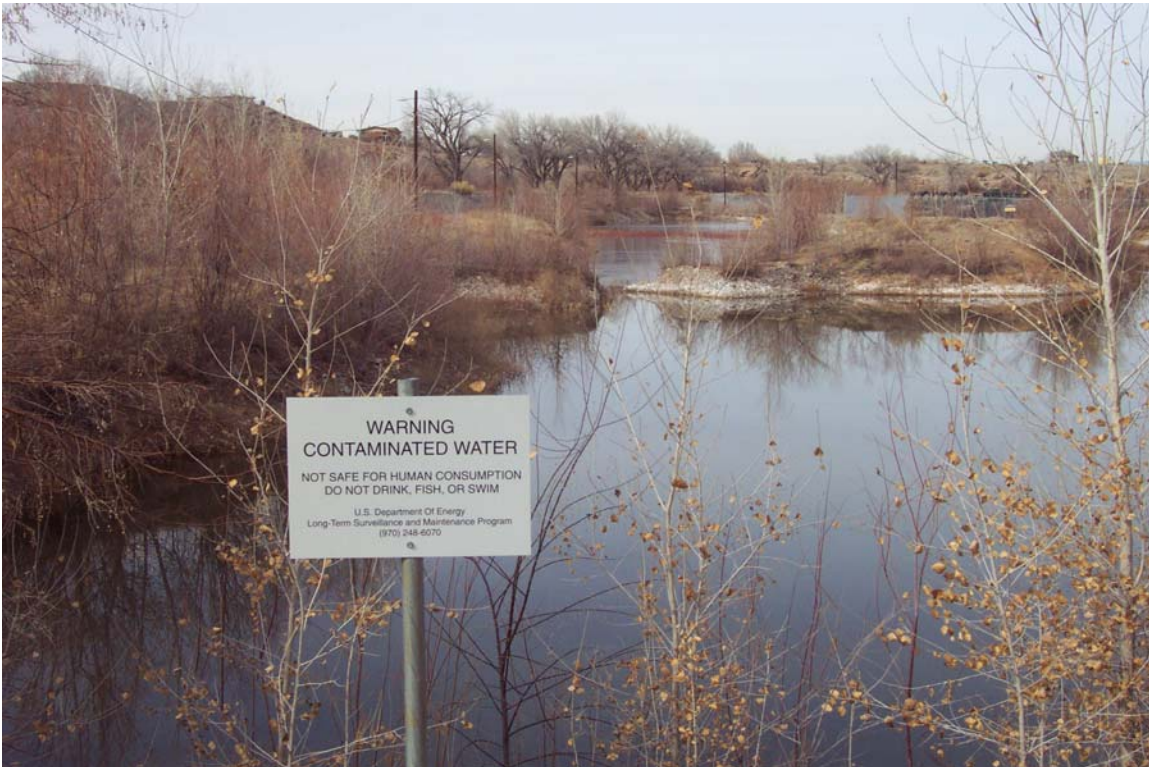
**Warning Signs**—Thirteen warning signs installed on galvanized steel posts are positioned around the surface water areas so the warning will be visible to a person approaching from any direction of reasonable access (PL–3). Dense vegetation or fences block access to portions of the surface water occurrences. All signs are in excellent condition. The signposts for warning signs S9 and S10 are loose and should be reset in concrete.

GJO 02/2003. PL-3. Warning sign S1 at south end of South Pond.

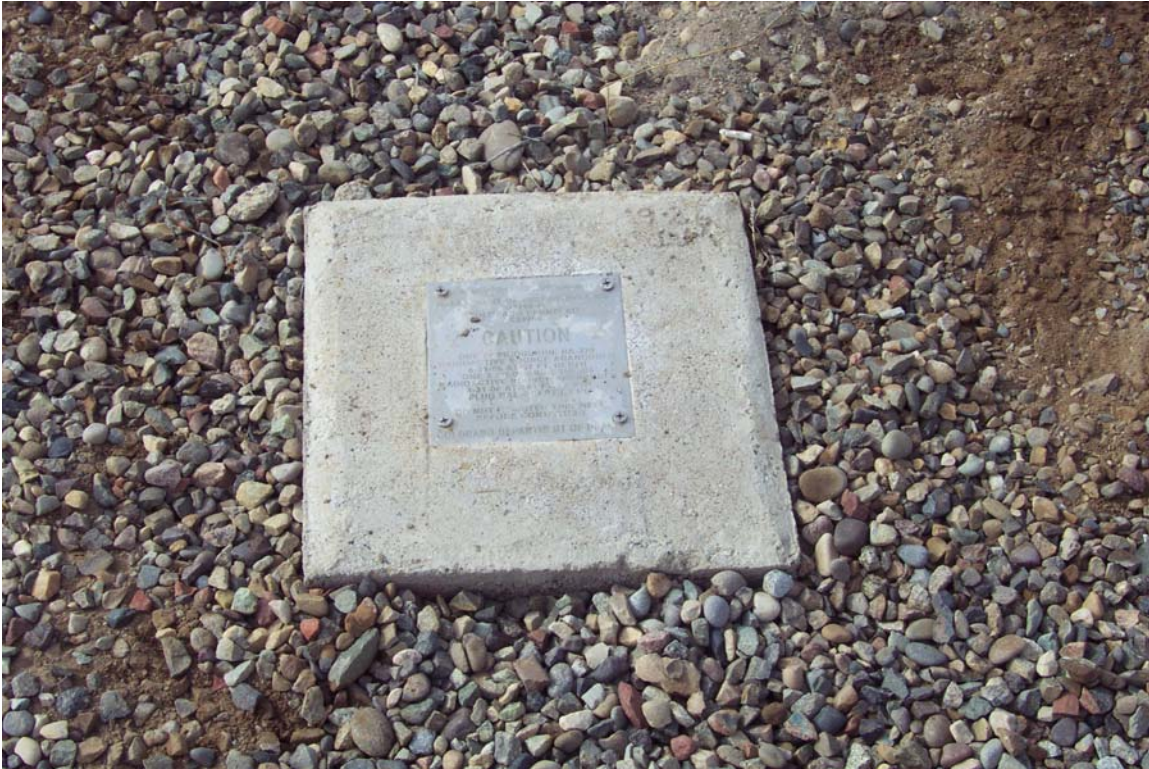
The borehole was decommissioned in place in 2000. DOE perforated the casing above and below each strip of foil and pressure-grouted the annulus with Portland cement to seal the foil in place. The borehole was filled with grout, and a metal plaque was mounted in concrete at ground level over the well. Borehole information printed on the metal plaque is fading and difficult to read (PL–4). It is recommended that the original plaque be replaced with a new metal plaque with the borehole information die-stamped or engraved into the metal.

3. The printed information on the plaque of the decommissioned 300-foot borehole is fading.

GJO 02/2003. PL-4. Plaque on decommissioned 300-foot deep calibration borehole.

**Recommendation:** Replace the plaque with a stamped or engraved metal plaque.

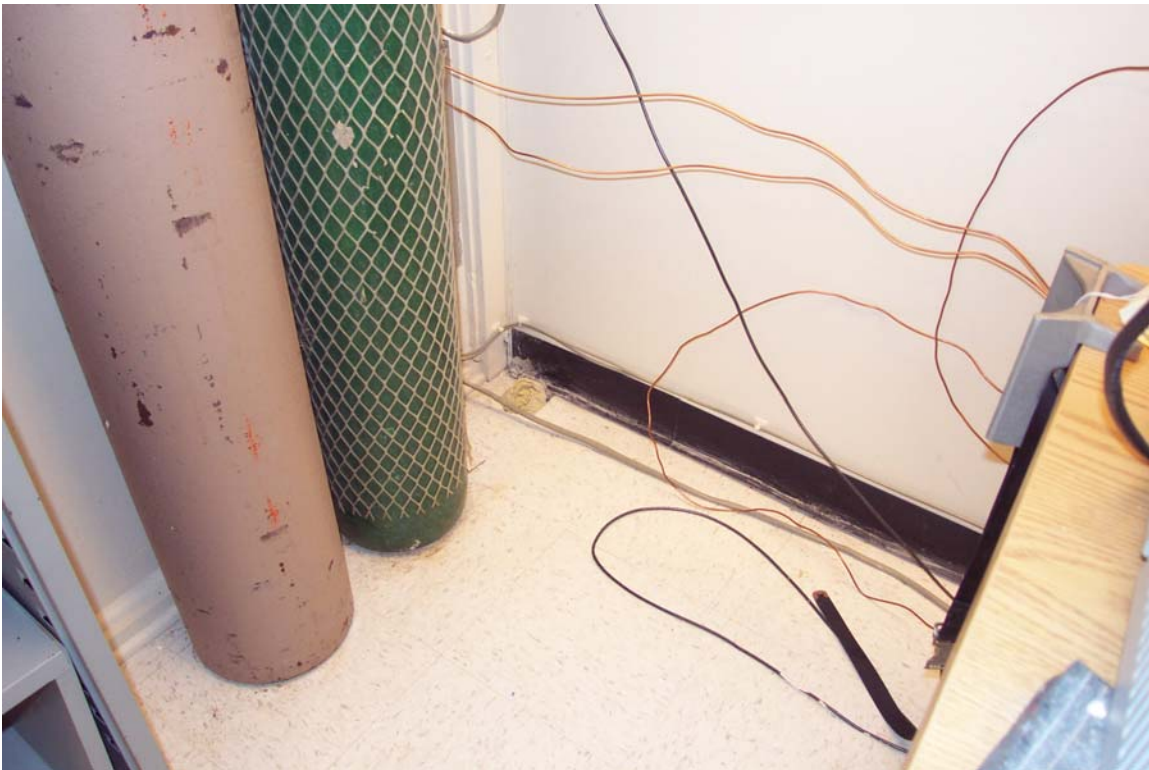
Inspectors entered Buildings 12 and 20 to inspect the floors above the contamination. A small hole plugged with paper was noticed in the southeast corner of Room 33B in Building 20 (PL–5). It may be an old test hole cored through the floor during radiological assessment of the building and should be permanently plugged. There was no evidence of recent floor penetrations in the affected areas. Likewise, the exterior areas opposite the contaminated media did not appear to have been disturbed. The current site owner controls maintenance activities in the exterior areas near the contaminated soil and GJO personnel constantly observe these exterior areas during normal working activities.

4. A small hole is in the floor in the southeast corner of Room 33B in Building 20.

GJO 02/2003. PL-5. Hole in floor in the southeast corner of Room 33B, Building 20.

**Recommendation:** Plug the hole with grout or other permanent material.
